# The installation of embedded ultrasonic transducers inside a bridge to monitor temperature and load influence using coda wave interferometry technique

# Xin Wang<sup>1</sup>, Ernst Niederleithinger<sup>1</sup> and Iris Hindersmann<sup>2</sup>

This article presents a unique method of installing a special type of embedded ultrasonic transducers inside a 36-m-long section of an old bridge in Germany. A small-scale load test was carried out by a 16 ton truck to study the temperature and load influence on the bridge, as well as the performance of the embedded transducers. Ultrasonic coda wave interferometry technique, which has high sensitivity in detecting subtle changes in a heterogeneous medium, was used for the data evaluation and interpretation. The separation of two main influence factors (load effect and temperature variation) is studied, and future applications of wave velocity variation rate  $\Phi$  for structural health condition estimation are discussed. As a preliminary research stage, the installation method and the performance of the ultrasonic transducer are recognized. Load- and temperature-induced weak wave velocity variations are successfully detected with a high

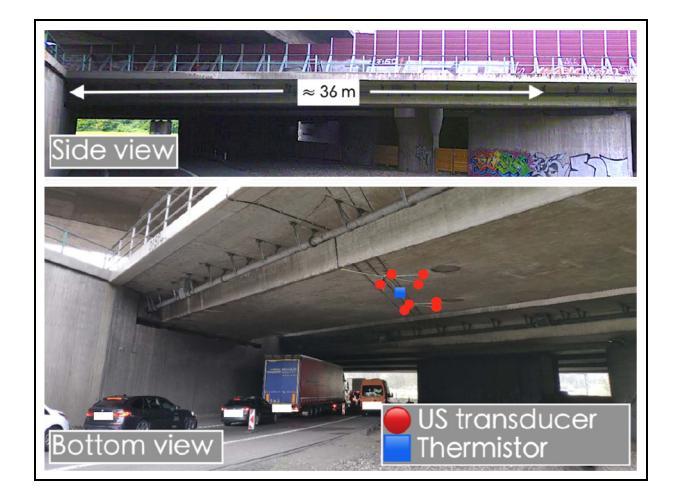
Figure 1. Side view and bottom view of duraBASt bridge.

The tested section of the bridge for this study was a 36-m-long and 15-m-wide box girder bridge (Figure 1). Eight embedded ultrasonic transducers and one thermistor were installed inside the bridge's lower section using a unique installation method. Detailed dimensions of the research object and locations of the sensors are presented in Figure 7.

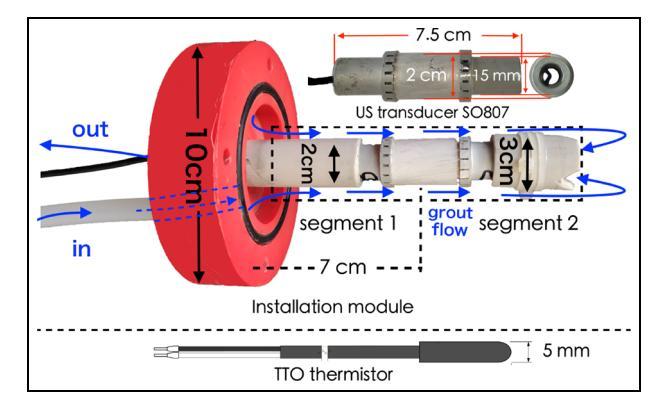
**Figure 2.** Transducer SO0807, sensor installation module, and thermistor TTO.

the structure and provide an option for long-term SHM, a special type of embedded ultrasonic transducer, "SO807," was developed. S0807 is a 7.5-cm-long hollow piezoelectric transducer (Figure 2). It could be operated as both transmitter and receiver. The primary frequency of SO807 is around 62 kHz, which is considered to be in the optimal frequency range for monitoring concrete using diffuse waves.<sup>51</sup> The next step is to install the transducer on existing structures. Hence, a special method was developed in Niederleithinger et al.<sup>20</sup>

Figure 2 shows an "installation module" consisting of a plastic base with a rubber band to fix its position and ensure a strong sealing to the structure surface, as well as two PVC tube segments to control the depth. The segment at the end was wrapped by a self-locking cable, and a notch was cut to ensure the smooth circulation of the grout. As a first step, the installation method was tested on a small concrete cube in the laboratory by following these steps: (a) Drill a hole with a diameter of 3 cm and with the desired depth; (b) Insert the sensor installation module and fix with screws; (c) Seal the gap with glue; (d) Pump in the grout slowly using a Makita DCG180ZX cordless cartridge gun. A slightly expanding and fast hardening type of grout was used. Grout flow is shown by the blue arrows in Figure 2. The grout gradually filled the gap between the module and concrete. Once the hole was fully filled by the grout, the grout would come out through the hollow space of SO807 and the PVC tube. The inlet was then be blocked. Figure 3 shows the longitudinal section of the tested cube. This installation method provided sufficient coupling of the transducer to the concrete in the laboratory.

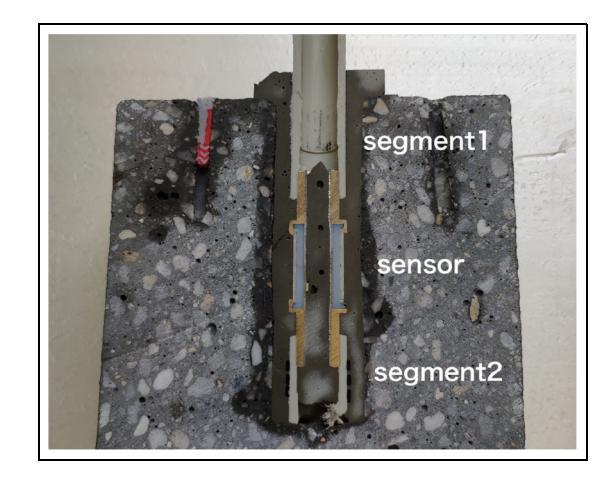
**Figure 3.** Longitudinal section of the tested specimen in laboratory.

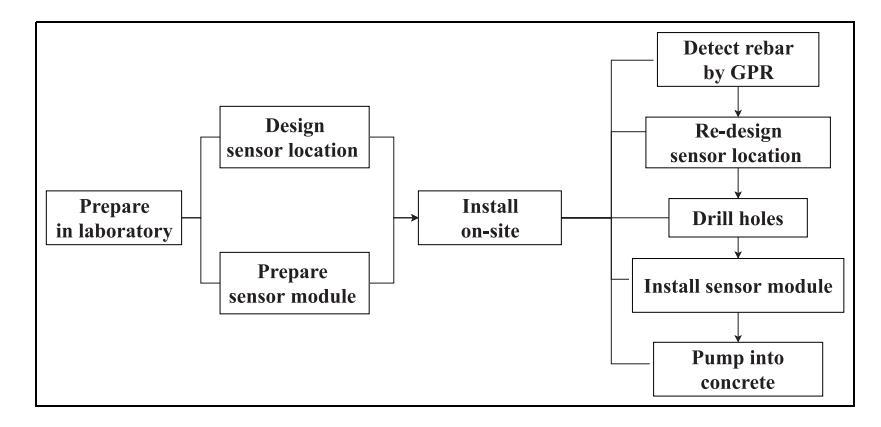
Figure 4. Diagram of the whole installation process.

It should be noted that the on-site installation was more complicated than that in the laboratory. The entire installation process followed Figure 4, and some processes are shown in Figure 5. Before drilling the

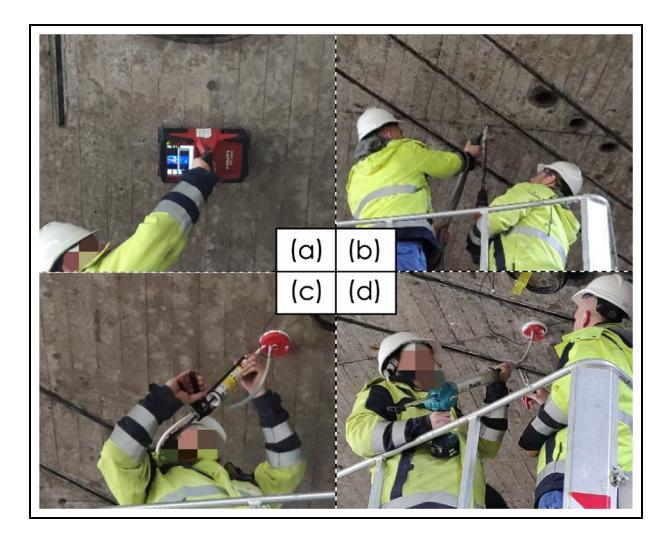
Figure 5. (a) Detect reinforcement by GPR, (b) drill hole, (c) seal the gap, and (d) pump in grout.

hole in the desired position, an examination by groundpenetrating radar was carried out to avoid hitting the reinforcement. In unexpected situations, such as the presence of holes or a void (Figure 6, blue circle), the transducer position should be modified slightly. The positions of the transducers were designed to be at the four corners of a square with a side length of 1.06 m. However, they were all modified on-site. The actual positions of all the US transducers are shown in Figures 6 and 7. The eight transducers were divided into two groups for convenience: group A contains transducer Nos 1-4, which were located in the middle of line A, and group C contains transducers Nos.5-8, located on the line C. The distance between each pair of transducers (SxxEyy: transmitter No.xx, receiver No.yy) is presented in Table 2. A thermistor "TT0" from Tewa Temperature Sensors Ltd. was installed in the middle of the line between US transducer No.3 and No.7 using a similar installation method. All the cables were placed in PVC tubes for better protection.

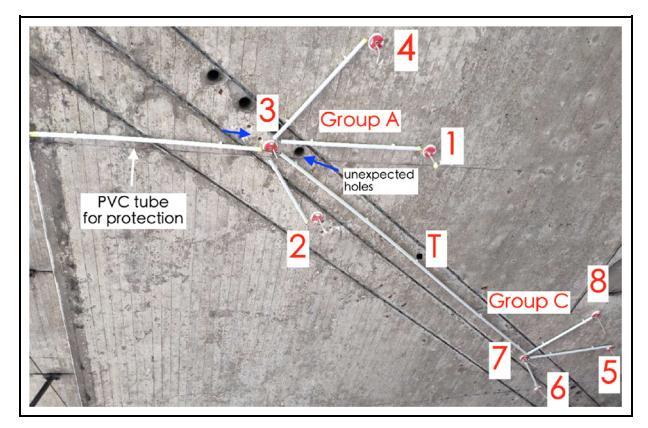
Figure 6. Actual position of all SO807 transducers and thermistor.

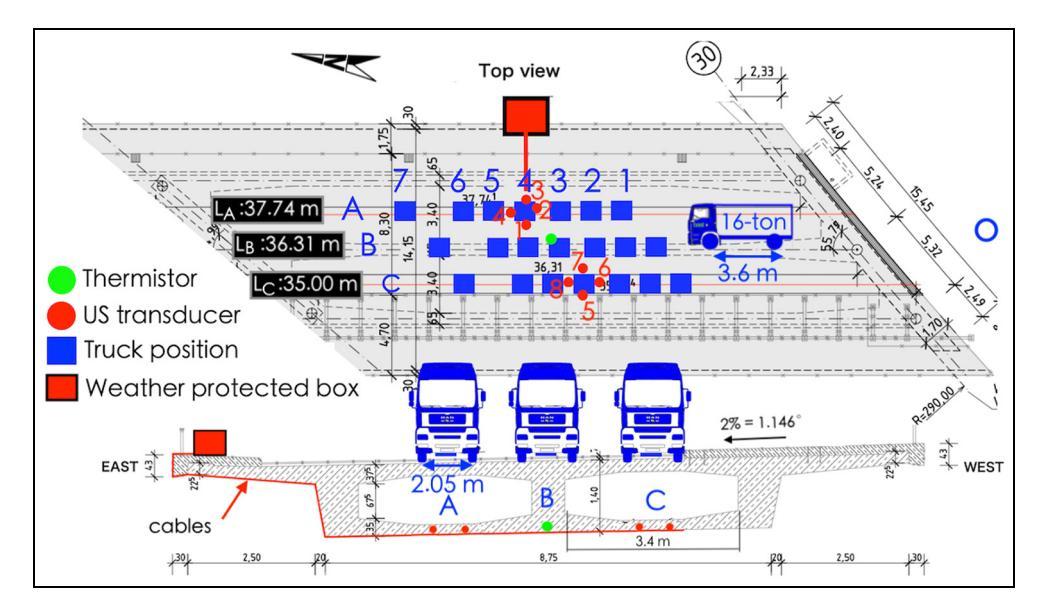
Figure 7. Sketch of the bridge, position of all sensors in top view, and all truck (load) positions along three lines.

parallel to axis B, which was the midline of the bridge. The lengths of axes A, B, and C are around 37.74, 36.31, and 35 m. The layout of the truck positions and transducer locations is presented in Figure 7. The measurement periods on axes A, B, and C were from 09:12:45 to 10:08:11, from 10:11:25 to 11:07:29, and from 11:19:03 to 12:15:03, respectively. Measurement on each line lasted around 56 min.

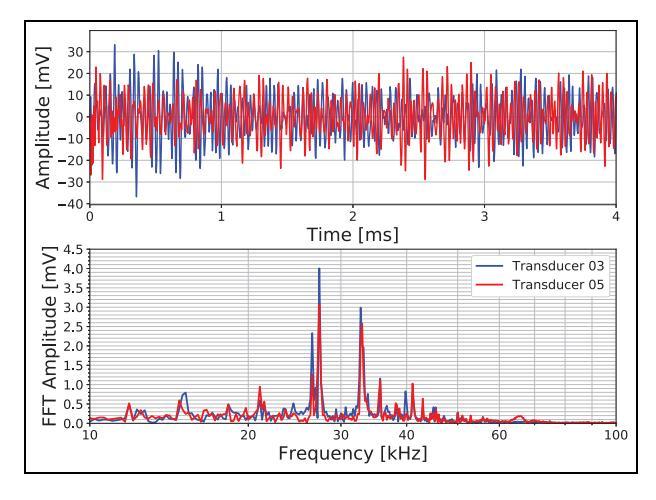
Figure 8. Environmental noise recorded by transducer Nos 3 and 5.

*Environmental noise.* All eight US transducers were performed as receivers to record the ambient environmental noise. The noises appeared randomly, but they all had similar amplitude and frequency components. The noises are most likely electromagnetic noise caused by the power line. Noises recorded by transducer No. 3 from group A and No. 5 from group C are, for example, presented in Figure 8 for instance. Their amplitudes

varied in the range  $\pm 30$  mV, which were relatively low, and the main noise frequencies were less than 40 kHz.

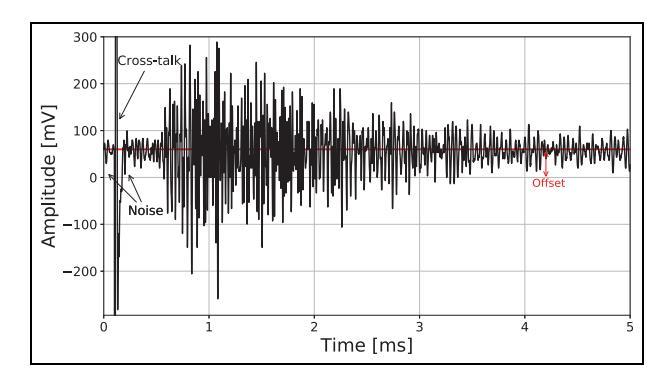
Figure 9. Raw US data recorded by the data acquisition system.

US signals. Figure 9 depicts a raw US data recorded by the data acquisition system used in this experiment. Due to the electromagnetic interference, a cross-talk was recorded when the excitation signal was triggered at 0.1 ms. A pre-processing procedure was required to remove the offset and crosstalk from the raw US data. Details of the procedure are presented in Niederleithinger et al.<sup>21</sup> A pre-processed US signal recorded by transducer combination S02E03 and its corresponding amplitude spectrum (FFT) are illustrated in Figure 10 in black. Transducer SO807 is

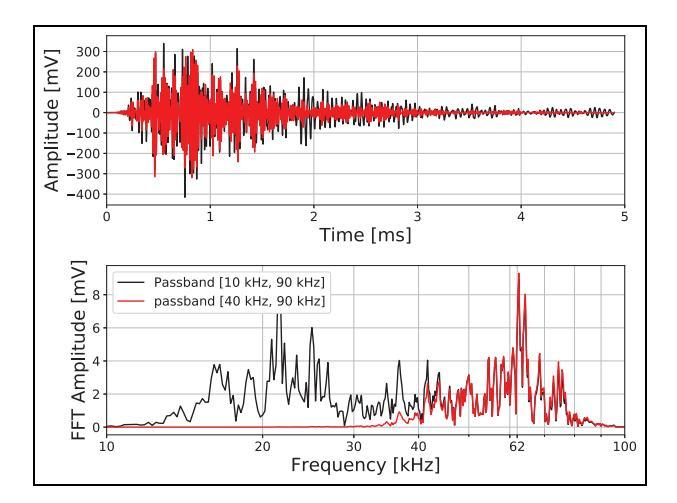
**Figure 10.** US data recorded by transducer combination S02E03 filtered by a band-pass filter with two passbands and their corresponding amplitude spectrum (FFT).

supposed to be most sensitive to 62 kHz, which is its central frequency. Thus, one of the main frequency distribution centers of the US signal is around 62 kHz. However, the other frequency components were distributed around 25 kHz. The authors assume that this is due to the stronger attenuation of higher frequency components and noise. To focus on the central frequency of SO807, the lower frequency components were filtered by a Butterworth band-pass filter (passband (40 kHz, 90 kHz), order 3) along with the noise. The filtered signal is shown in Figure 10 in red.

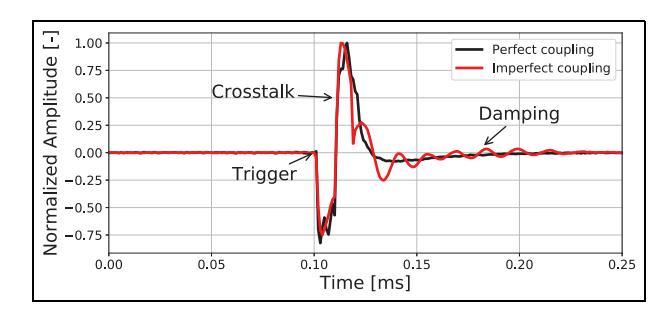
Figure 11. Influence of coupling condition on crosstalk at 1 ms.

Coupling condition examination. As SO807 is a piezoelectric transducer, US signals are generated by the expansion and contraction of its piezoelectric ceramics part. When the transducer and concrete are coupled perfectly, the concrete absorbs the vibration of the piezoelectric ceramics part immediately. However, when the coupling condition is not ideal, the remaining vibration generates extra current and sends it back through the cable, which affects the cross-talk. Figure 11 depicts the crosstalk of two signals recorded under two coupling conditions. The imperfect coupling condition caused a damping of the crosstalk. Unfortunately, in this study, all eight SO807 transducers had imperfect coupling to the concrete. Nonetheless, their performance in this experiment still met the expectation that the US signals recorded by the SO807 transducers can

be used to detect the temperature variation and different load positions. It is presumed that there are two types of imperfect coupling conditions. One is caused by the weathering of the grout, which creates a fine gap between the grout and the concrete. In this case, the US signal energy has a great loss. The other type is caused by the different damping ratio of the grout, which prevents the vibration energy of the ceramic part being absorbed in a short period.

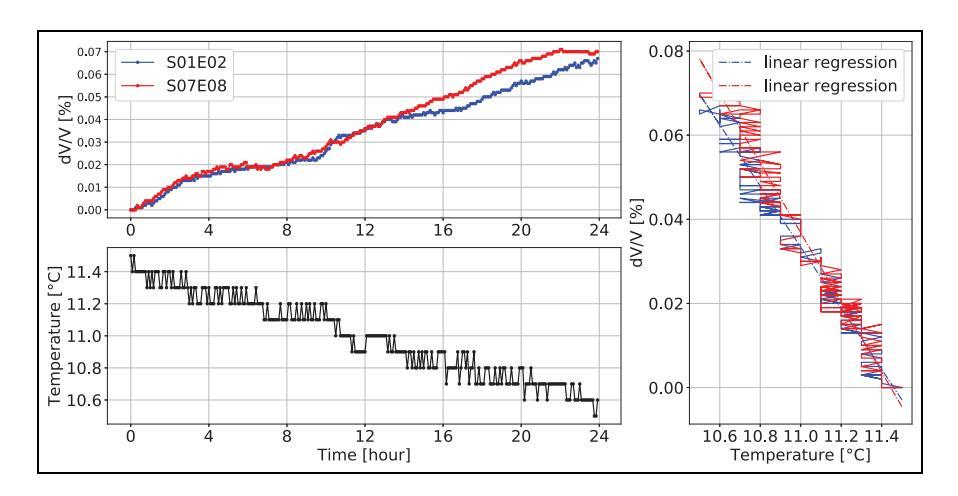
**Figure 12.** dV/V, temperature variation, and the corresponding dV/V-temperature curve measured by transducer combination S01E02 and S07E08.

The bridge was monitored for 24 h. dV/Vs measured by transducer combination S01E02 and S07E08 are shown in Figure 12 as examples. During this period, the internal temperature of the bridge decreased 1°C from 11.5°C to 10.5°C. The dV/Vs increased almost linearly with the temperature. The slopes of the linear regression of the temperature-velocity curves are considered as the  $\Phi_T$ . The  $\Phi_T$  s of all the transducer combinations are listed in Table 4 as  $\Phi_T$ 1. Most of the  $\Phi_T$  s are around -0.1%/°C; the largest value was -0.157 %/°C, measured by transducer combination S02E03. Prior studies have obtained different  $\Phi_T$  s in different structures and under different temperature ranges. These  $\Phi_T$  s are summarized in Table 5. The  $\Phi_T$  s calculated in this study correspond well to the existing studies.

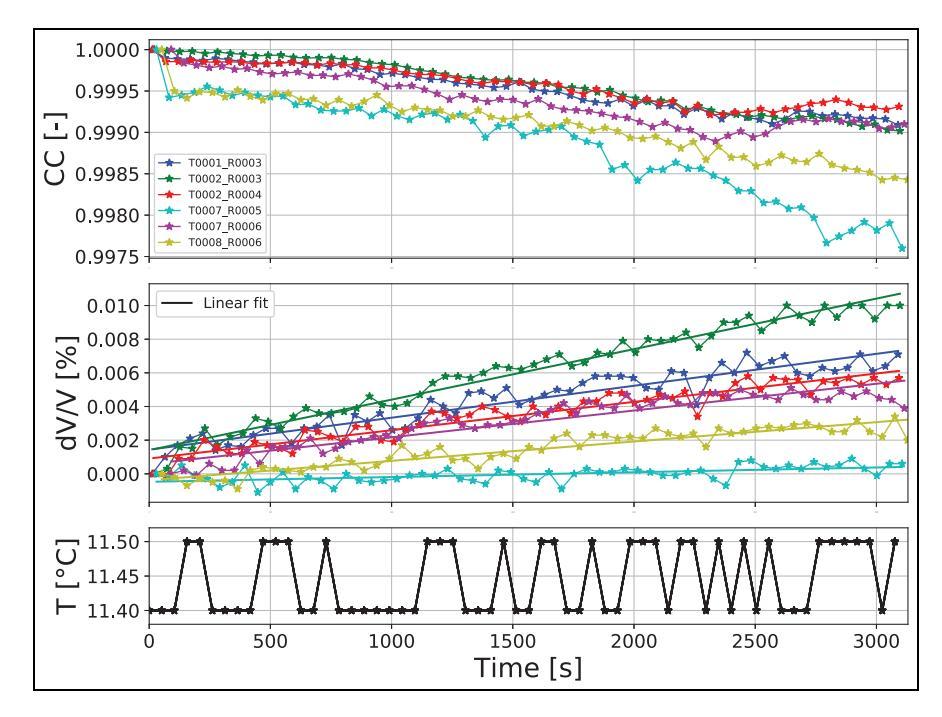
Figure 13. Correlation coefficient and relative velocity change of six transducer combinations during 50 min without load.

The CC and dV/V measured by six transducer combinations located in both box girders, as well as the temperature variation, are shown in Figure 13 as an example. In comparison with the first reference signal, the maximum CC change was measured by transducer combination S07E05, which decreased to 0.9976. The maximum relative velocity change measured by these six transducer combinations was  $1 \times 10^{-2}$ %, and the minimum was  $6 \times 10^{-4}$ %. The CC of transducer combinations from group A varied less and more smoothly than that of transducer combinations from group C, for the reason that the CC measured the similarity of the signals, and the amplitudes of signals which had stronger energy were less affected by unexpected factors (i.e. noise). However,

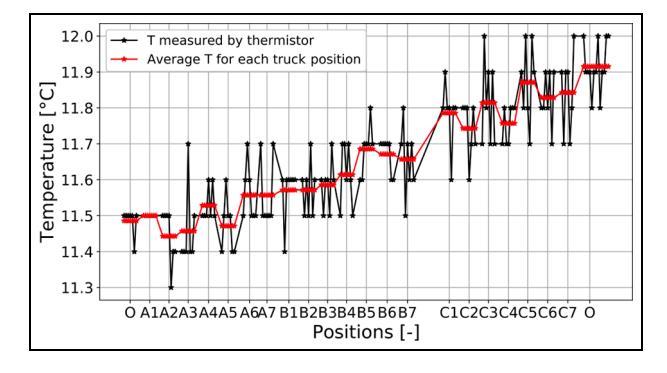
**Figure 14.** Temperature variation during the whole load test and average temperature of each truck position (O: without load).

each line). The temperature variation is shown in Figure 14 in black. The temperature increased by about  $0.5^{\circ}$ C during the whole load test. Due to the accuracy limit of the thermistor, the temperature fluctuated strongly by  $\pm 0.1^{\circ}$ C. Assuming that the temperature remained the same during the measurement in each truck position, the average of all seven temperature measurements at each position was considered as the temperature (Figure 14 in red).

C decreased the least. As one can see, the temperatureinduced dV/V compensation for lines A, B, and C increased gradually, which was following the temperature variation in Figure 14.

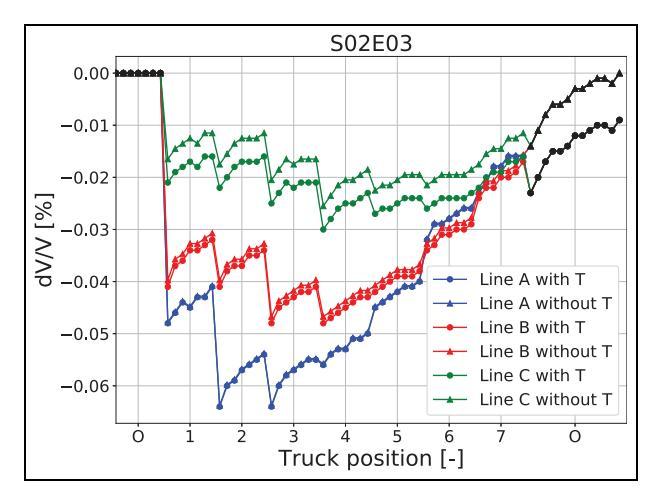
**Figure 15.** Relative velocity change and temperature compensated velocity change of transducer combination S02E03 in all seven positions of each lines.

illustrated in Figure 15. When the truck left the bridge, dV/V returned to -0.009%, which was different from the initial state. For transducer combination S02E03, a temperature increase of 0.6°C led to a velocity loss of 0.009%; assuming the linear behavior, the  $\Phi_T$  of transducer combination S02E03 is then -0.015%/°C.  $\Phi_T$  s of all transducer combinations are listed in Table 4 as  $\Phi_T 2$ . Comparing to  $\Phi_T 1$ , the value of  $\Phi_T 2$  is much smaller and closer to the  $\Phi_T$  s found in another bridge in Wang et al.<sup>52</sup> And  $\Phi_T 2$  was estimated by the signals measured during the load test; thus, the temperature effect in the dV/Vs was eliminated by  $\Phi_T 2$ . The curves with circle markers represent the relative velocity variation without temperature compensation, and curves

with triangle markers describe the temperature compensated dV/V. dV/V successfully detected the 21 positions of the truck. However, the dV/V in each truck position did not remain stable but rather increased slightly, this being due to the residual influence of the previous truck position. The concrete takes time to recover to a stable state because of the creep effect. When the truck moved along line A, the dV/V decreased with a bigger range, as transducer combination S02E03 was located in the middle part of the line A. Likewise, the dV/V along line

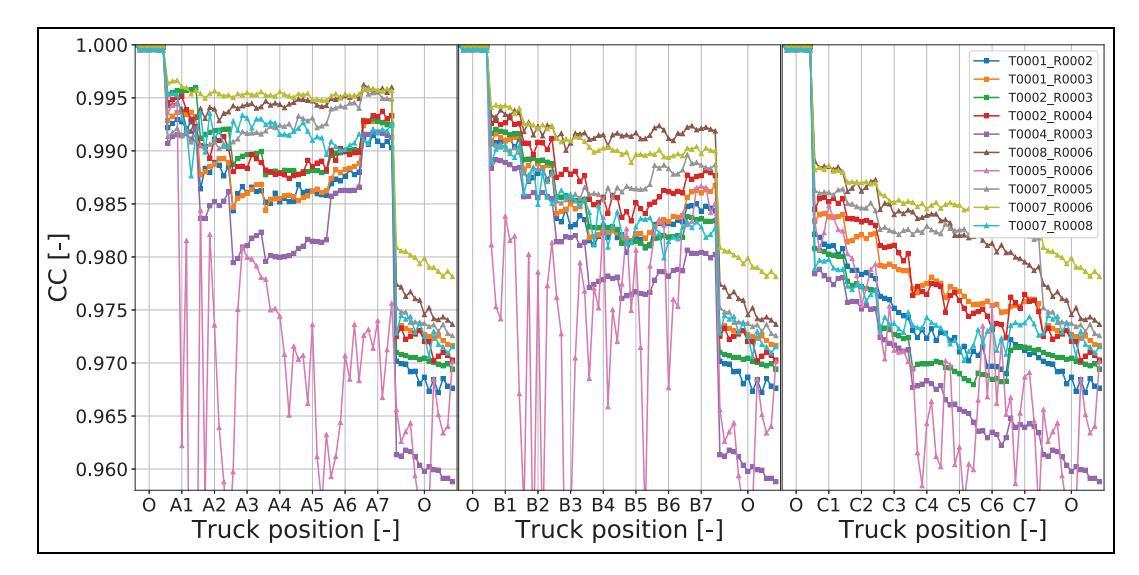
Figure 16. Correlation coefficient of all transducer combinations in all positions.

CC and temperature-compensated dV/V of all transducer combinations. The CC and temperature-compensated dV/V measured by all transducer combinations are illustrated in Figures 16 and 17. The CC presented here is not temperature compensated as the CC is non-unique. The CC is not directly related to the elastic property of the material or the wave velocity change. Having said that, the CC can still provide some useful information as it measures the similarity between signals. Different truck positions can still be identified from some of the CC curves. It is notable that the CC of transducer combination S05E06 did not provide any useful information as it fluctuated too much. The average energy of the signals recorded by this transducer combination was 139 mV<sup>2</sup>, which was weak, inferring that the coupling condition between transducer No. 5 and the concrete was poor. When transducer No. 5 was used as a transmitter, the wave energy had a more significant loss.

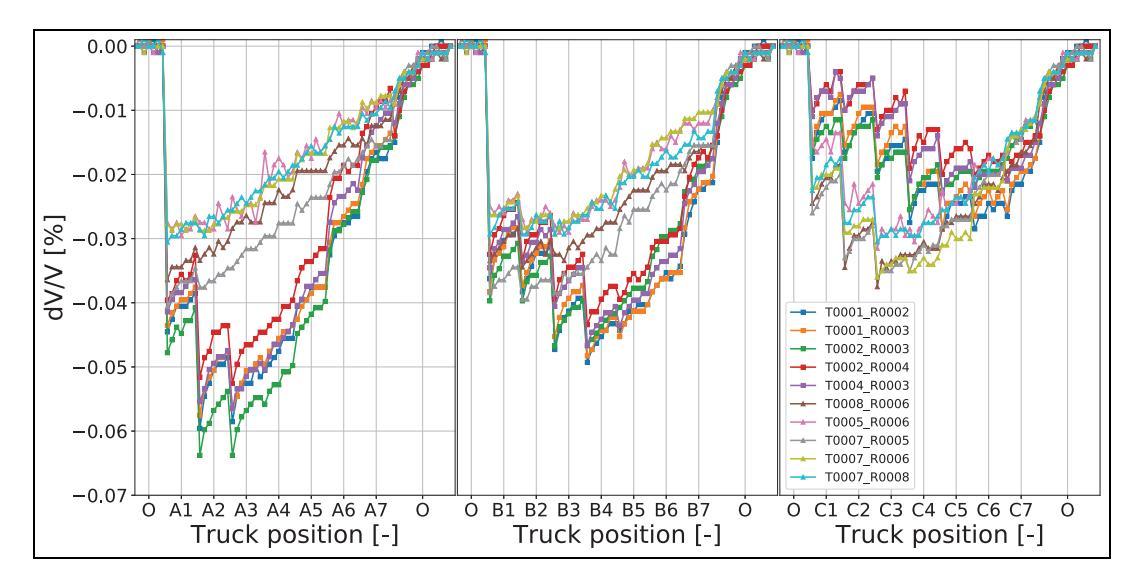
Figure 17. Temperature compensated relative velocity change of all transducer combinations in all positions.

The dV/Vs measured by transducer combinations from groups A and C are well separated. According to Figure 17 (left), when the truck moved along line A

from position 1 to position 7, the dV/V of the transducer combinations from group A detected these different positions. The dV/V reached its lowest value when the truck moved to positions 3 and 4, which were located right above the transducers. The dV/V of the other transducer combinations from group C decreased to their minimum value when the truck was in position A1 and then started to increase approximately uniformly until it reached position A7. Because the truck was not located directly on line C, the influence of the load on the transducers from group C was lower. The effect of the load and of the residual influence from the previous truck position was superposed. Compared to when the truck was on line A, when the truck moved along line B, the overall dV/V of all group A transducer combinations increased and that of group C transducer combinations decreased, as the truck moved away from line A and got closer to line C. Figure 17 (right) shows the dV/V variation when the truck moved along line C. Most of the transducer combinations detected the different truck positions. Even transducer combination S05E06, which provided useless CC information, identified position C1, C2, and C3. When comparing the three dV/V graphs for the three lines, transducer com-
